## Note 71B

### Cylinder liners in compression

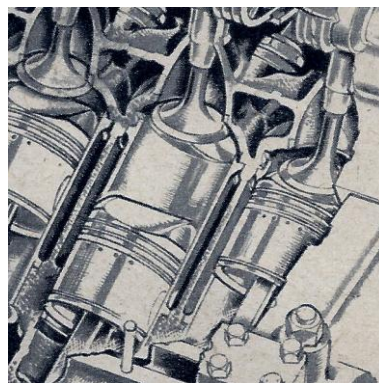
The racing engine designers were in good company in falling into the trap of cylinder liners retained in compression. Rolls-Royce built the same thing into the *Merlin* in 1937 when the Mk II was hastily fitted with the ex-*Kestrel* layout (which leaked (900)) after the Mk I "ramp head" engine proved unreliable (see Fig. N71B(A)). It was not until 1942 when the "two-piece-block" having a top-flange-located liner finally went into production (initially at Packard in the USA) that the cylinder leakage problem at high boost in fighter duty was overcome.

Ironically, the Mk I had a top-flange-liner-location!

Fig.N71B (A)  
The Rolls-Royce *Merlin* Mk II  
cylinder layout.
